Manhole Inspection Summary

Manhole # S15YY_012MH

Location Address: **3541 REISTERSTOWN RD**

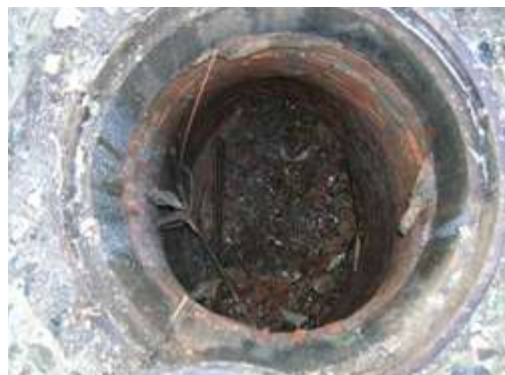
Top View

Corroded and missing steps. Channel debris.

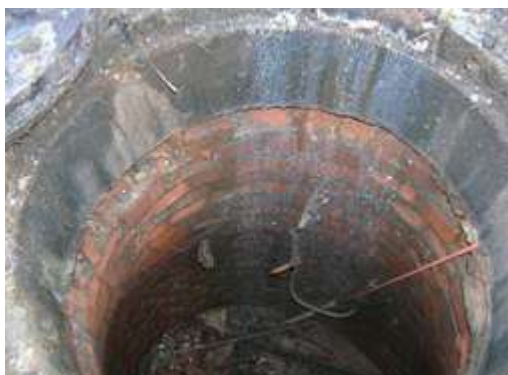
Defect

Frame leaks. Adjustment deterioration, loose brick and infiltration. Barrel infiltration - other side.

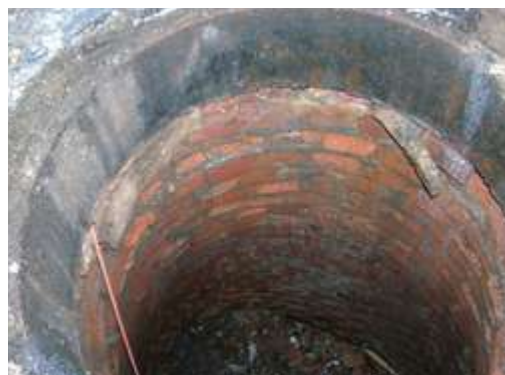
Defect

Frame leaks. Adjustment deterioration, loose brick and infiltration. Barrel infiltration.

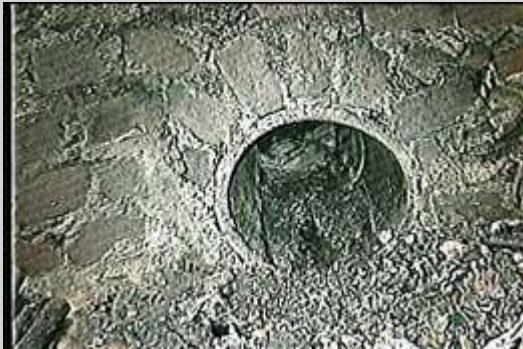
8 in. Circular Gravity Sewer
Pipe Out @ 12 O'Clock

Barrel deterioration and infiltration.
